City of Tensed ID-0025101 Inspection Date: 7/26/2011 Photo Log TRIM Record: 2011AGF2210 Page **2** of **11**

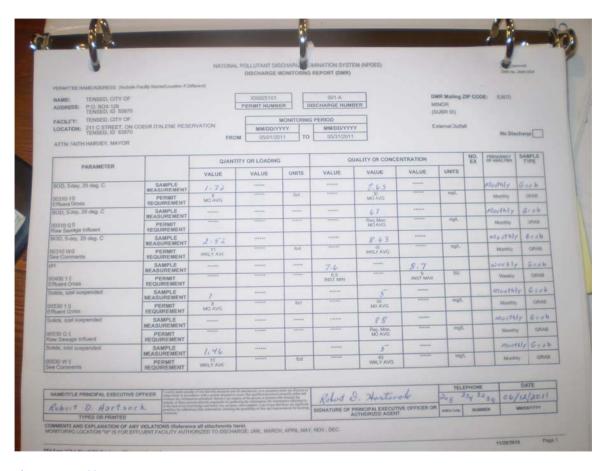
Figure 1. June 2011 DMR.

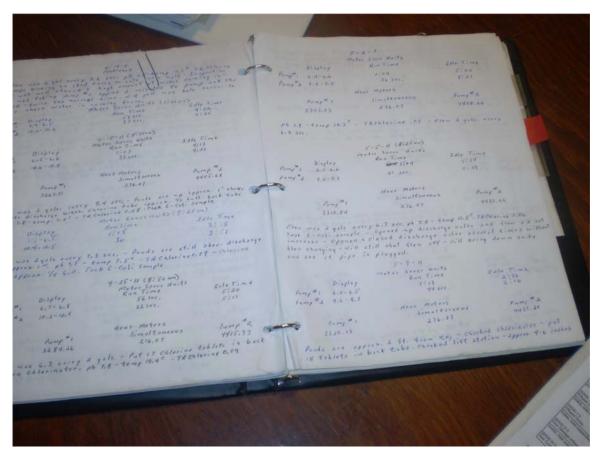
Figure 2. Operations log for Tensed.

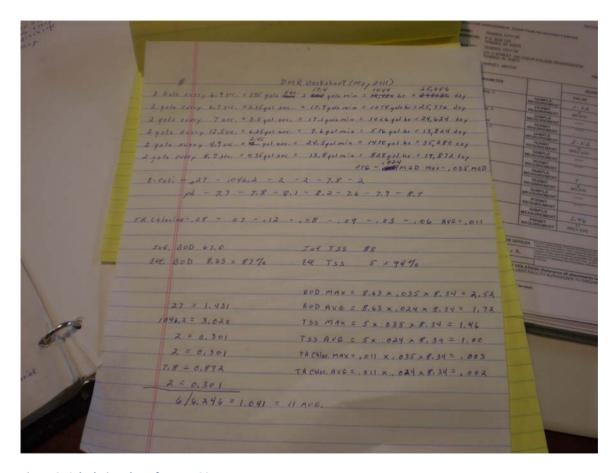
Figure 3. Calculation sheet for June 2011 DMR.

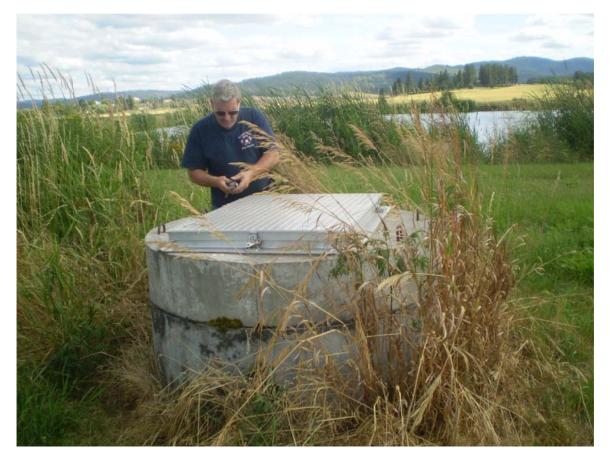
Figure 4. Operator unlocking lift station at lagoon site.

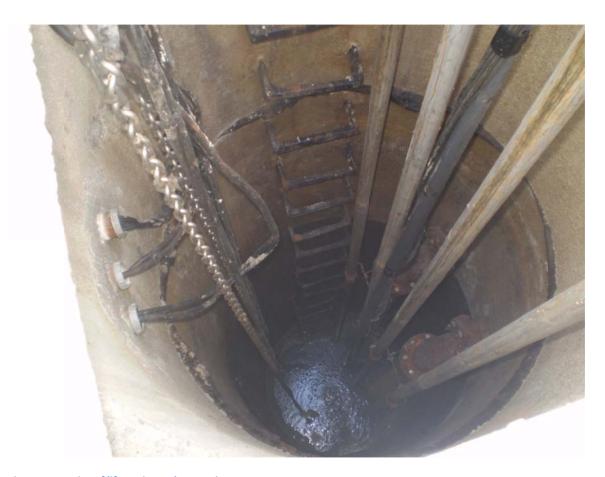
Figure 5. Interior of lift station at lagoon site.

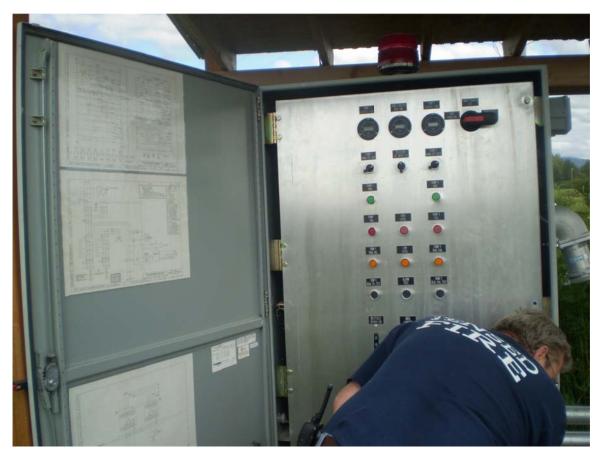
Figure 6. Pump control panel at lagoon site.

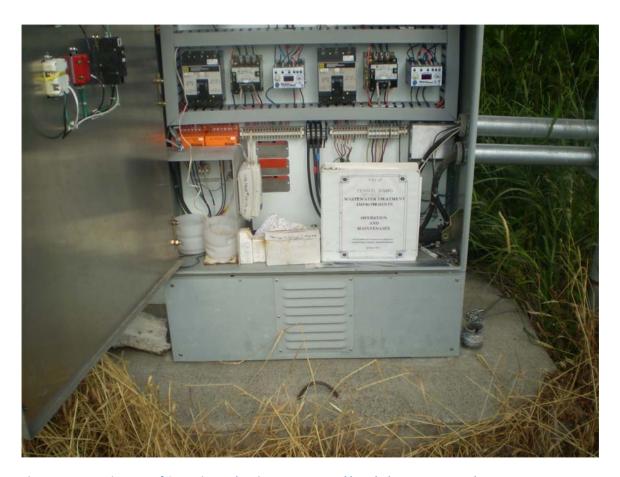
Figure 7. Lagoon site copy of Operation and Maintenance manual kept below pump controls.

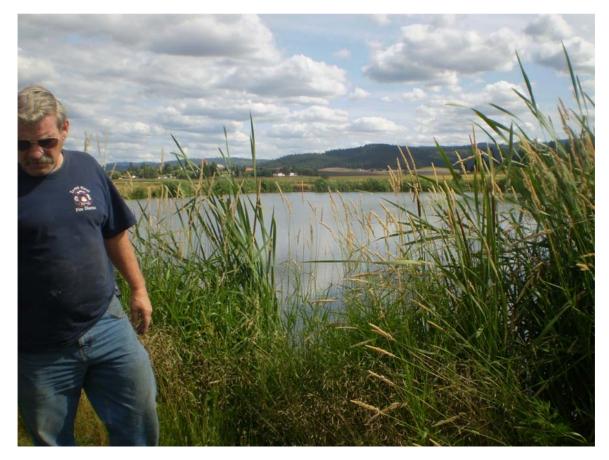
Figure 8. Looking west at Lagoon #2.

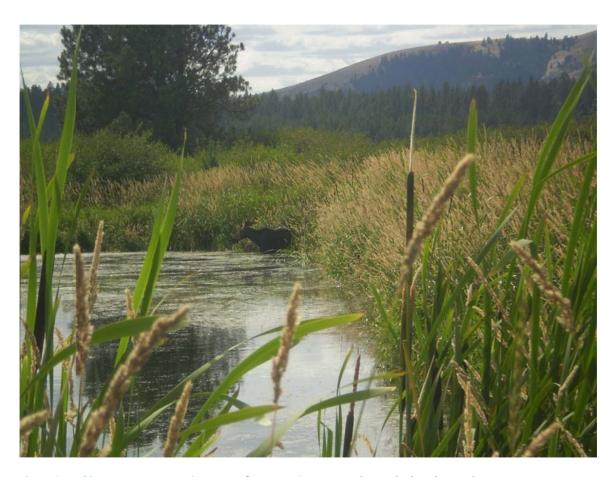
Figure 9. Looking west at a moose in corner of Lagoon #2. Note weed growth along lagoon berms.

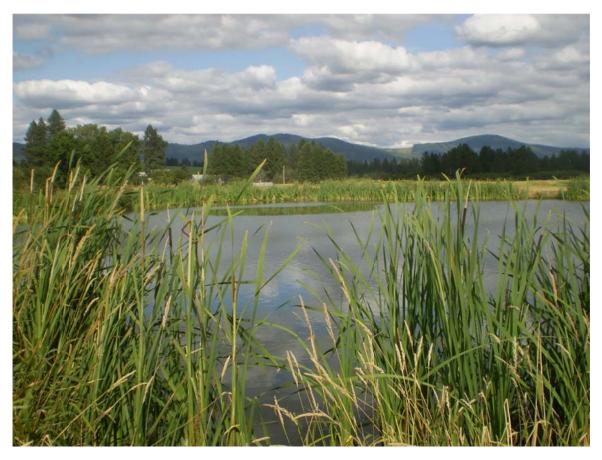
Figure 10. Looking northeast at inlet (smooth water area) into Lagoon #1.

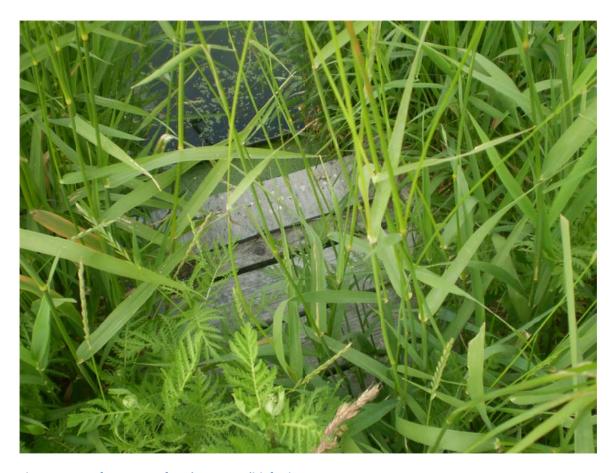
Figure 11. Transfer structure from lagoons to disinfection.

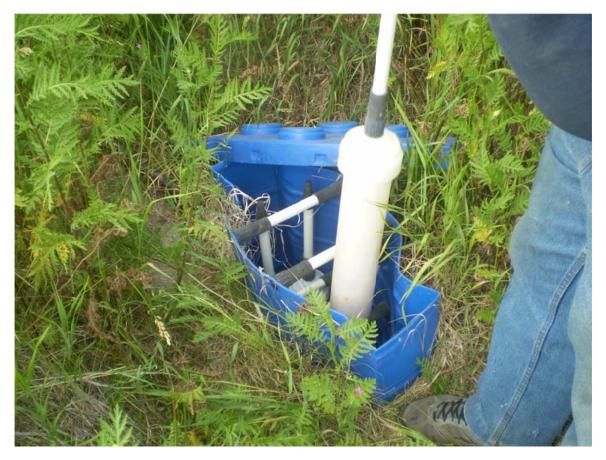
Figure 12. Sodium hypochlorite tablet holder in disinfection chamber.

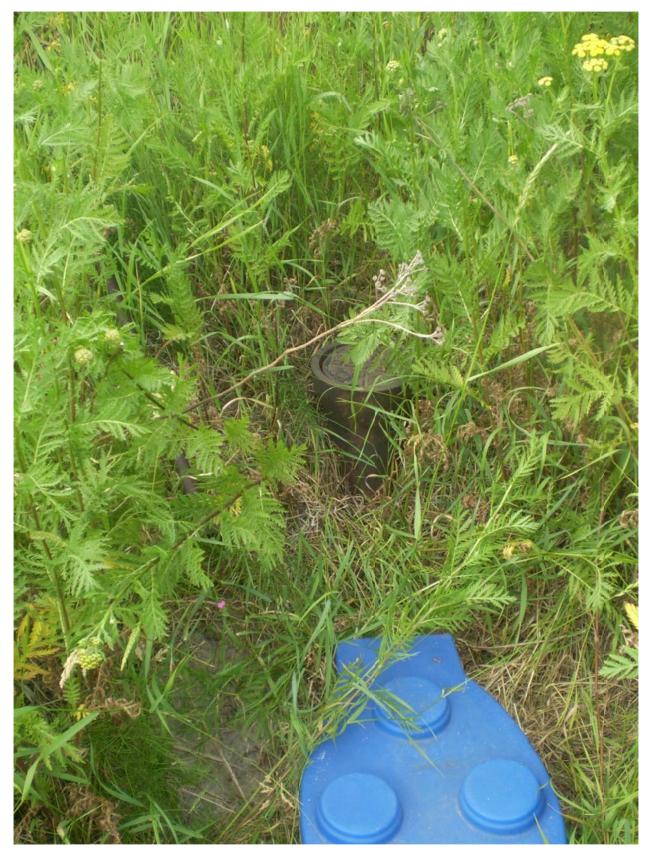
Figure 13. Valve to allow effluent to flow through disinfection chamber.

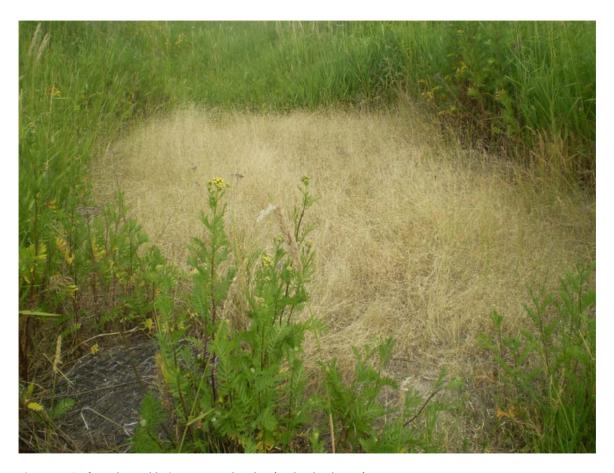
Figure 14. Surface above chlorine contact chamber (under dead grass).

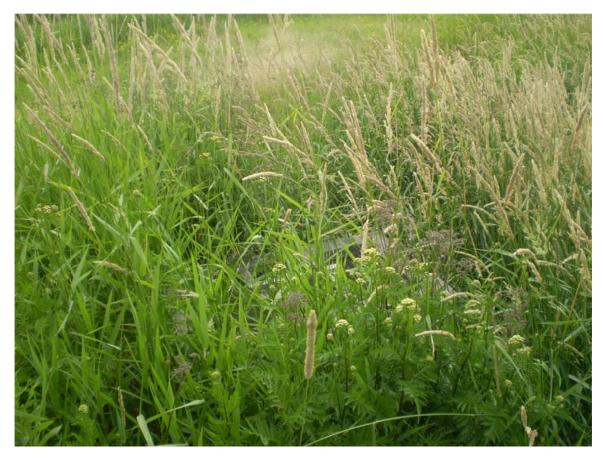
Figure 15. Flow structure between chlorine contact chamber and final settling pond (hidden in long grass and weeds).

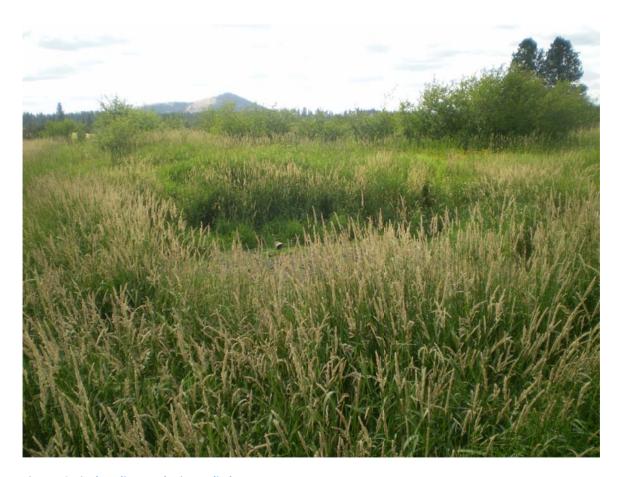
Figure 16. Final settling pond prior to discharge.

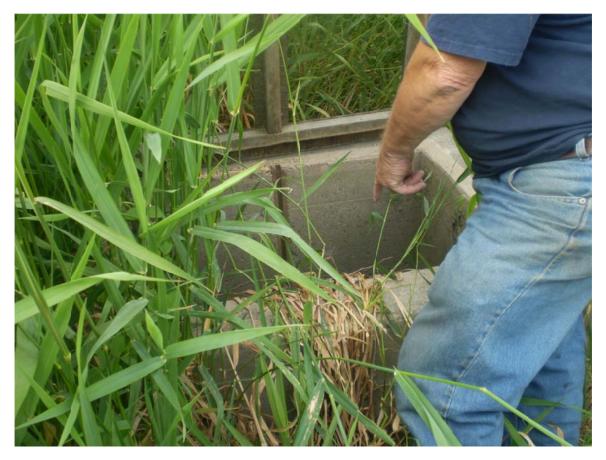
Figure 17. Effluent sampling weir.

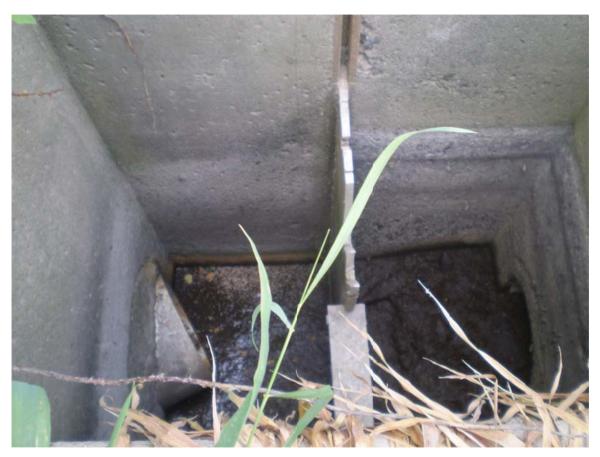
Figure 18. Interior of effluent sampling weir. Note high water marks in left side of vault, reportedly from high runoff this spring.

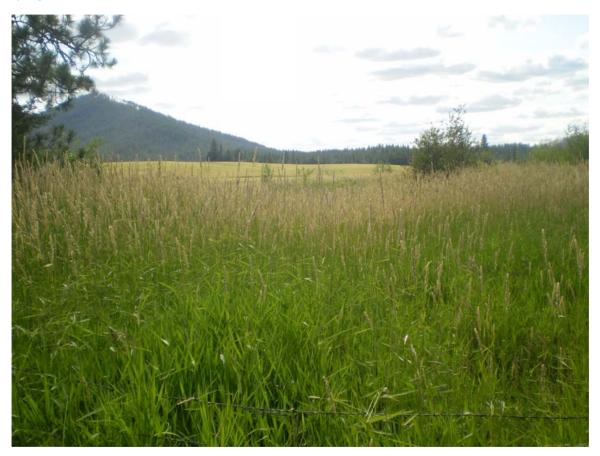
Figure 19. Discharge point to Hangman Creek (approximately 200 feet away near center of photo).

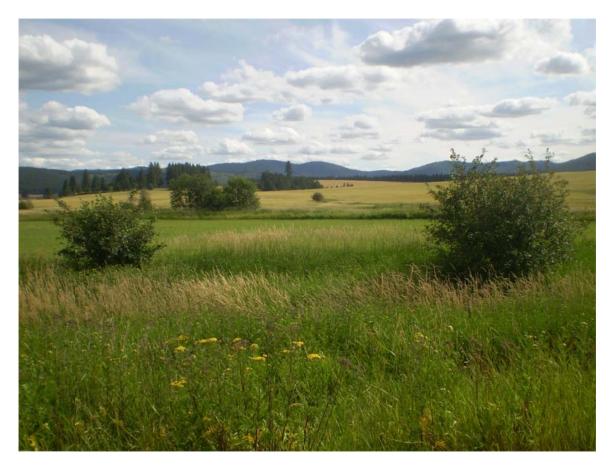
Figure 20. Looking southeast toward Hangman Creek (dark green line of vegetation) from lagoon berm.
